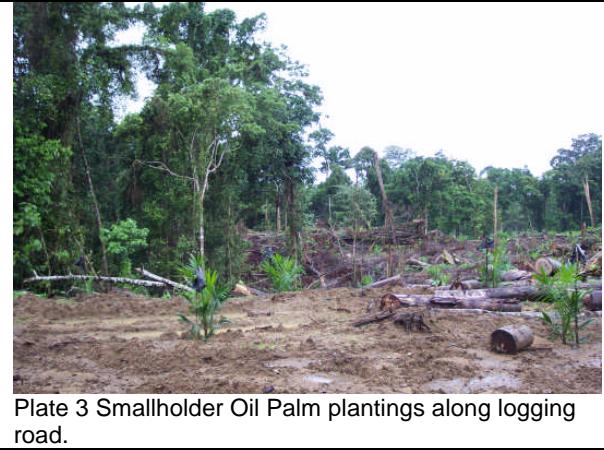
<p>This photo shows the expansion of smallholder oil palm plantings in logged over forest.</p> <p>The plantings are a long distance from the oil palm mills and once logging in the area has finished there will be the inevitable problem of transporting the fresh fruit bunches to the mill.</p> <p>The absence of reforestation levies (and current policy regarding use of the levies) prevents PNGFA assisting the villagers to reforest logged areas.</p>

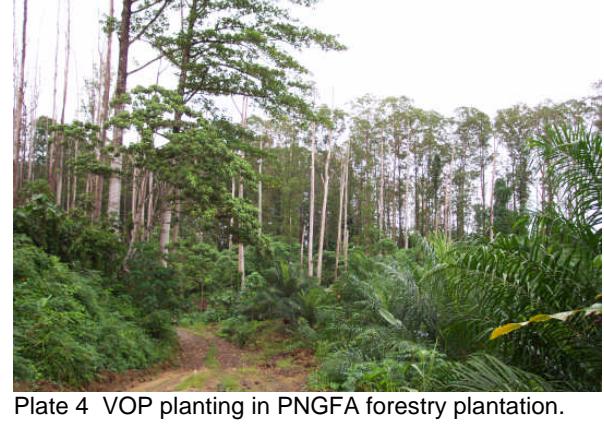
<p>This photo shows how villagers have established smallholder oil palm plantings in a PNGFA owned forestry plantation, at Mosa.</p> <p>The PNGFA owned plantation of <i>Eucalyptus deglupta</i> suffered damage by fire in the “el nino” event of 1997/8 and villagers have planted oil palm in the gaps left by the fire.</p> <p>The Oil Palm Industry Corporation (OPIC), the organisation that assists Village Oil Palm development has a policy that VOP blocks should not be established unless the land tenure of a block is clarified and secure.</p>

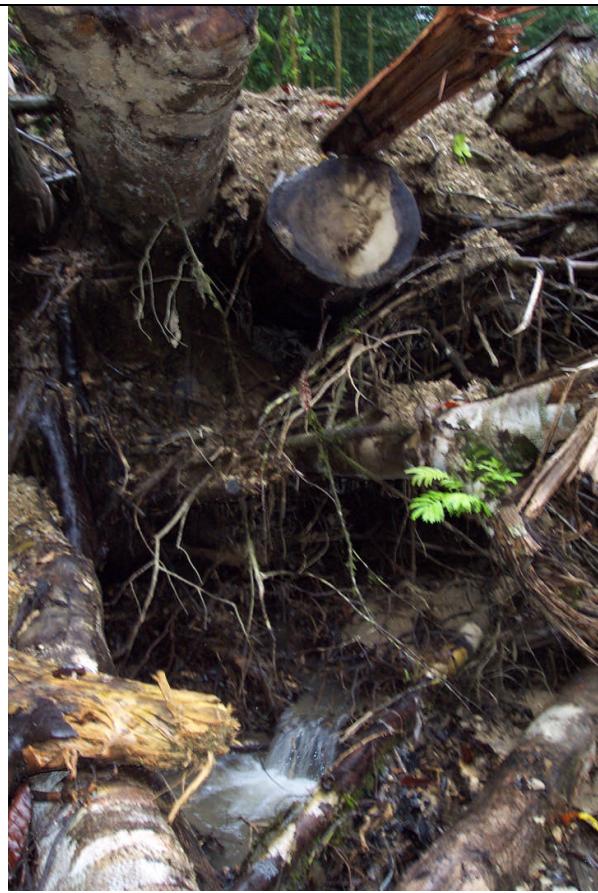
Plate 5 Log Clusters used for water crossing.

Photos 5 and 6 were taken in a set-up (G45-03) that had recently been logged.

The photos illustrate that log clusters have been used to cross a Class 2 stream (breach of Key Standard No. 13).

Photos 5,6, and 7 illustrate the need for greater supervision of the logging contractor by the Permit Holder, PNGFA and DEC.

There is excessive soil and debris in the streambed, which has caused the siltation above the crossing. The logs and debris must be removed before the set-up can be closed.

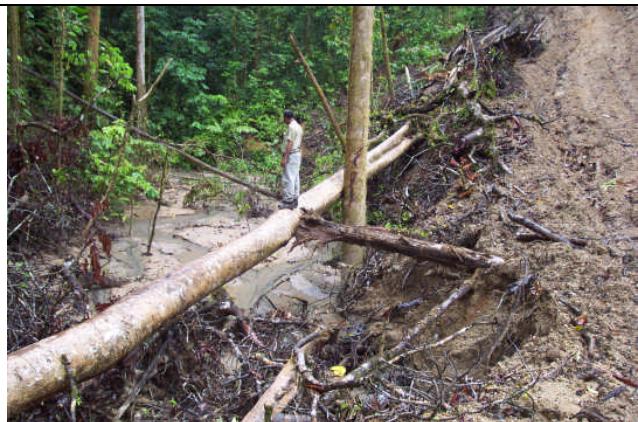
Plate 6 The log cluster has caused siltation in the stream.

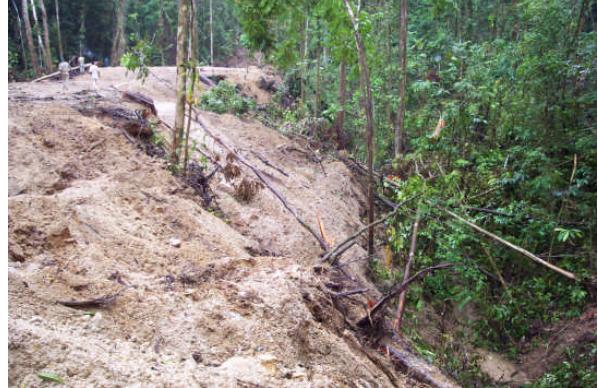
Plate 7 A transit camp in a stream buffer zone.

This photo shows the remains of a disused transit camp, which has been established within set-up G45 –03, within the buffer zone of a Class 2 stream (breach of Key Standard No.2). A bulldozer has been used to flatten the campsite and soil pushed into the streams.

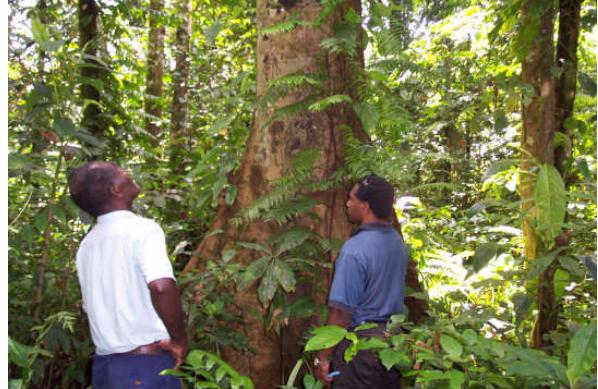
Plate 8 Twenty year old regeneration of *O. sumatrana*.

This tree is located in a research plot established in 1984 just prior to logging.

The area before logging, contained several trees of commercial size and there was much damage to the residual crop during the felling and extraction process.

The tree shown regenerated after logging and has a diameter above buttress of over 80 cm.

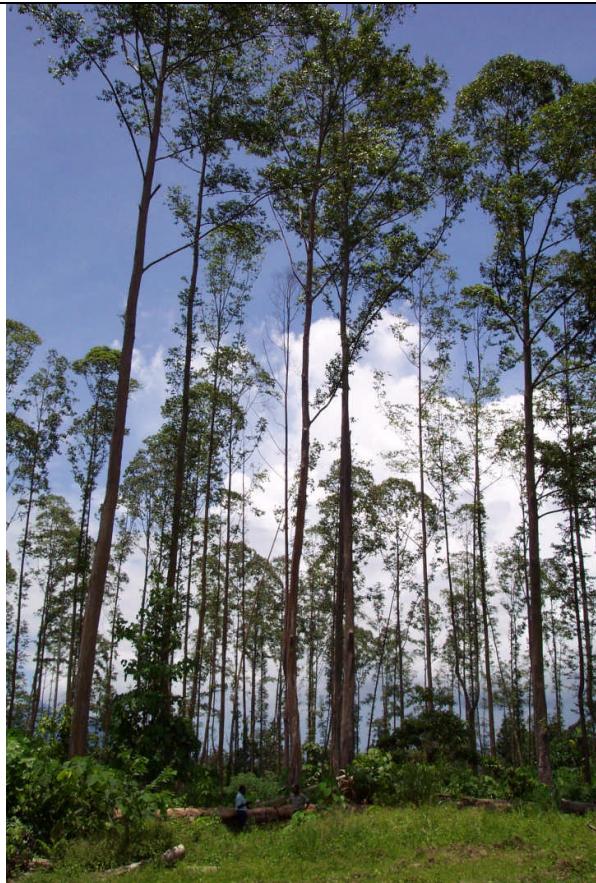
Plate 9 Trees left standing after “clearfelling”.

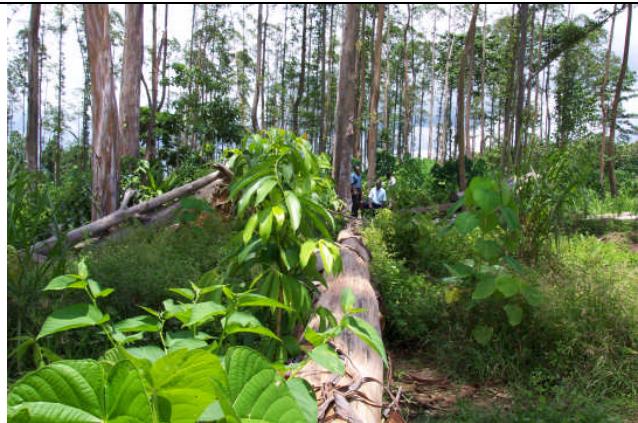
Plate 10 Wastage in the form of logs and standing trees in a “clearfelled” SBLC Eucalyptus deglupta plantation.

The poor form of the trees left standing was the reason given by SBLC for the lack of market for these logs.

Trees left standing will be bulldozed and burned during the preparation of the area for replanting.

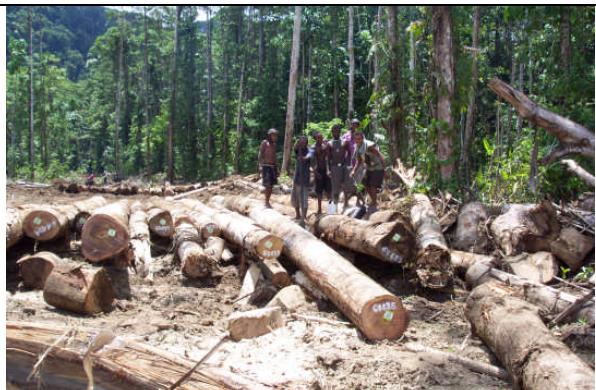
Plate 11 Trimming logs in a logged over plantation.

These logs are predominantly *Octomeles sumatrana* (erima).

The scaler trims to lengths of 6,8,10 and up to 16 metres, thus if a log due to be scaled is of uneven length, say 7.5 metres, there is considerable waste of sound timber.

Yields from these plantations are approximately 70% of estimates obtained by inventory, and considerably less than yields obtained from Open Bay plantations.

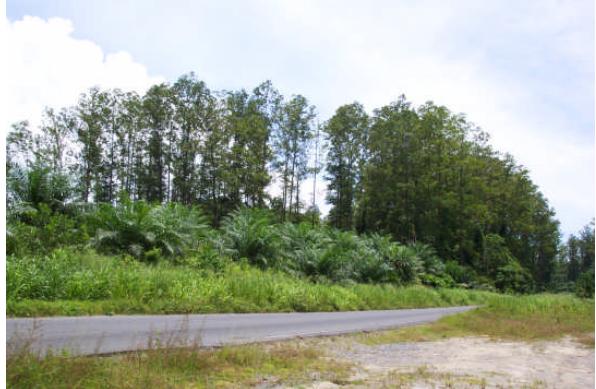
Plate 12 A “buffer” of E.deglupta left standing.

This photo illustrates an attempt by SBLC to deter the expansion of illegal establishment of oil palm on land leased to the company for reforestation.

The plantation behind the buffer has been logged and replanted, the buffer has also had trees felled.

If the buffer was not left, it is possible that illegal VOP establishment would have encroached into the SBLC plantation as has occurred on the opposite side of the road (not shown).
