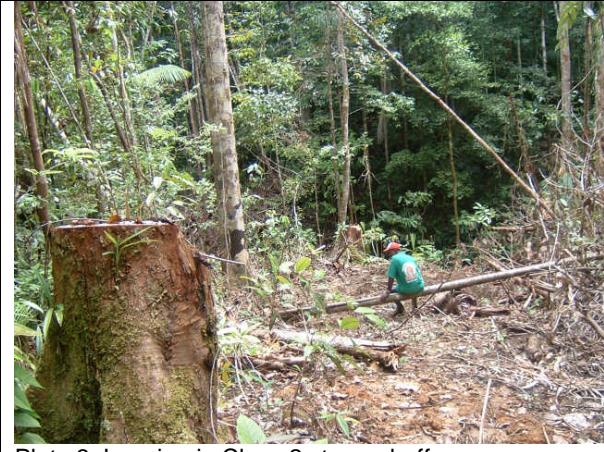
Plate 3 Logging in Class 2 stream buffer.

Set-up C99 of the re-entered area. The operator has skidded into a Class 2 stream buffer in breach of Key Standards 2e, 16,17).

The stump (mersawa), could have been cut lower for maximum timber utilisation as the log will inevitably be trimmed.

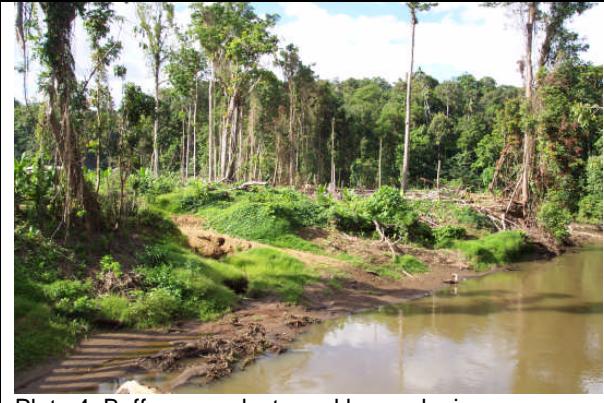
Plate 4 Buffer zone destroyed by gardening.

Destruction of vegetation along the bank of the Turama River by employees living at the Base Camp (Block 3), for gardening purposes.

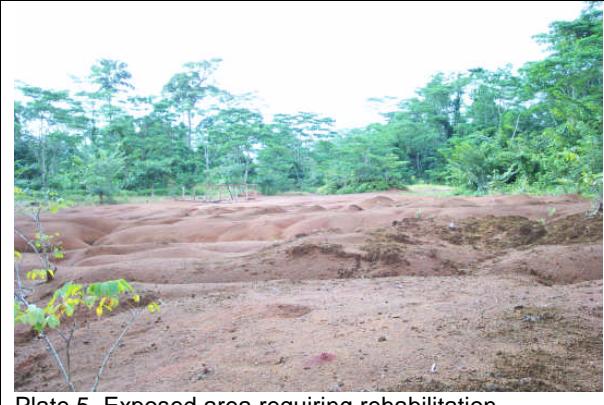
Plate 5 Exposed area requiring rehabilitation.

This photo illustrates an area where topsoil has been removed and laterite excavated for road surfacing. Attempts to rehabilitate the site by planting rosewood stakes have failed. An organic mulch would assist in the regenerative process.

There are many such "moonscapes" particularly near the Kamusie base camp where past road clearance has exceeded the 40 metre limit (Key standard 9.).

The Review Team noted that *Alstonia scholaris* (milky pine) was successfully regenerating in many such areas.

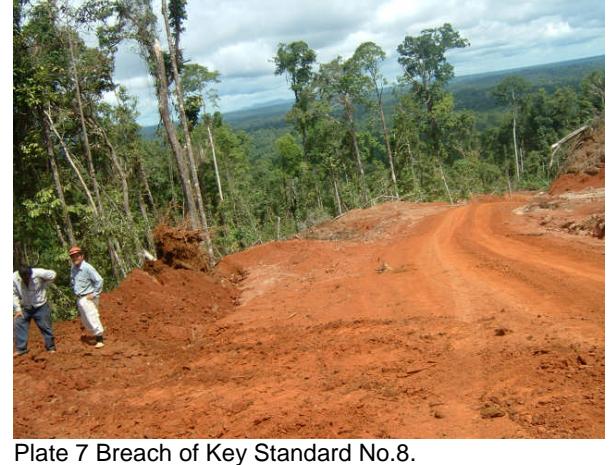
<p>An unapproved deviation from a surveyed road line. Construction work was stopped by the Regional Inspector. The deviation has since been approved. This is a breach of Key Standard No. 8.</p>

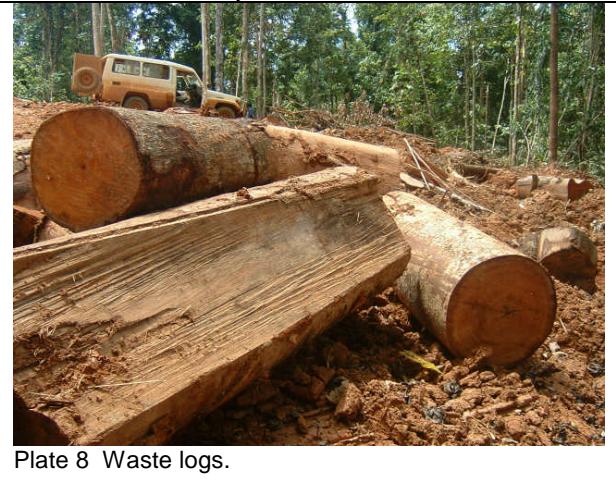
<p>This waste timber is a result of mechanical damage during handling of the otherwise sound logs. These waste pieces should be considered for processing or waste assessment.</p>

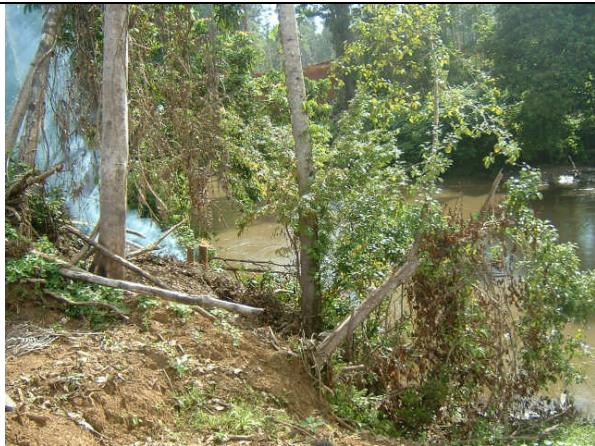
Plate 10 Gardening along the Turama River.

A further example of destruction of Class 1 buffer zone by gardening by employees of the logging company.

The PNGFA Regional Inspector instructed the employee to cease clearing the buffer zone.

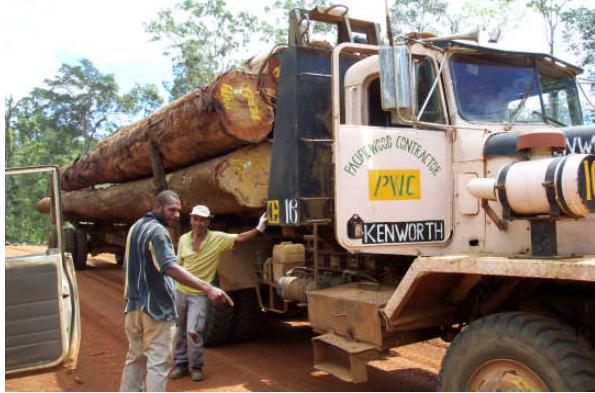
Plate 11 Jinker driven with no safety chain.

This expatriate Jinker Driver was stopped because of the absence of a chain to secure the load of logs. The vehicle was also not registered.

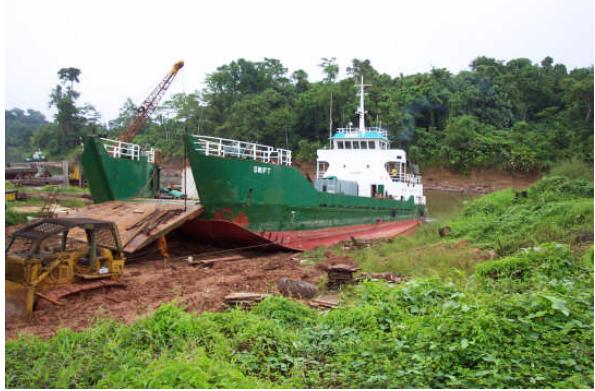
Plate 12 The Bank of the Guavi River breached.

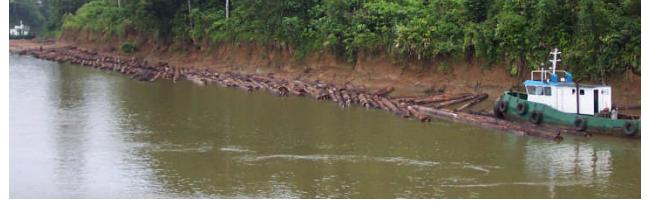
Plate 13 Logs are still rafted down the Guavi River.

It is difficult to control the raft of logs once it is in motion so this adds to the bank erosion.

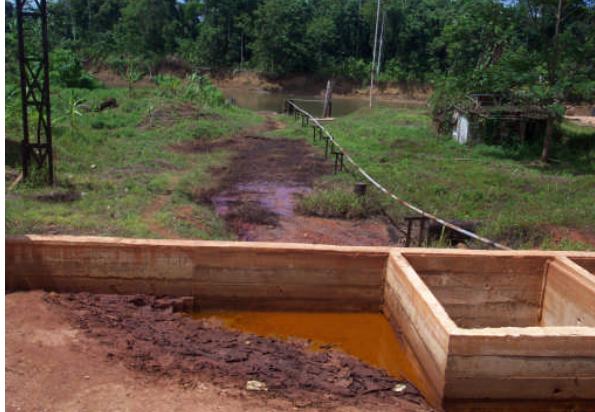
Plate 14 This concrete bund, ( built in November 2003) does not stop fuel oil leaking into the Guavi River.

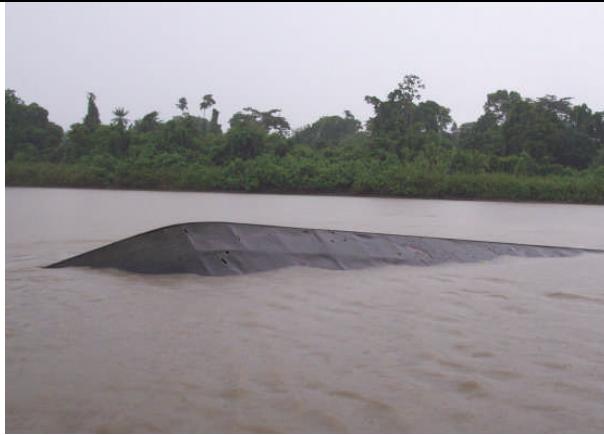
Plate 18 Sunken Barge near Emeti.

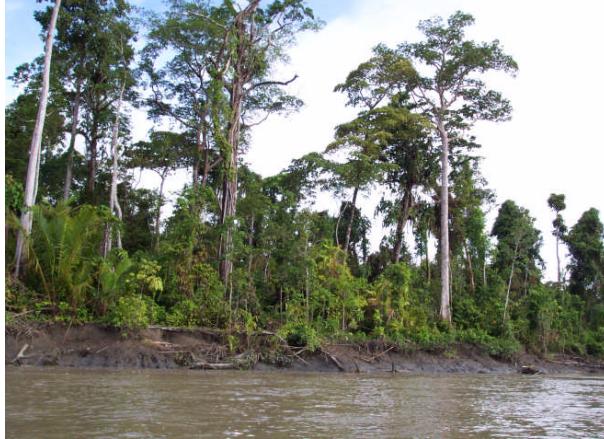
Plate 20 Erosion at Station 3.

This photo shows erosion at Station 3 along the banks of the Bamu River.

Landowners claim that siltation of the river has caused increases in the number of times there is a tidal bore and the height of the waves.

The Review Team noted that the erosion increased the further we travelled towards station 5, which is the last staging post on the way to Omuda, (where logs are loaded onto the ships for export).

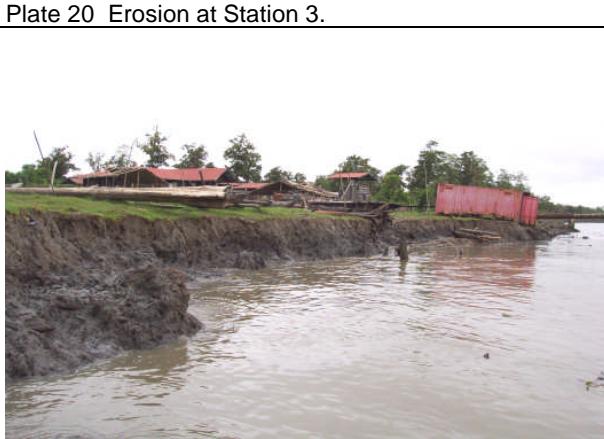
Plate 21 Serious erosion at Station 5.

Station 5 on Dibiri Island.

A combination of vegetative clearing, river traffic and tides has caused serious erosion on the foreshore where the Base Camp is located.

← This log illustrates where the jetty once reached. Buildings have been relocated inshore.

Protective measures are urgently required to stabilise the foreshore.
