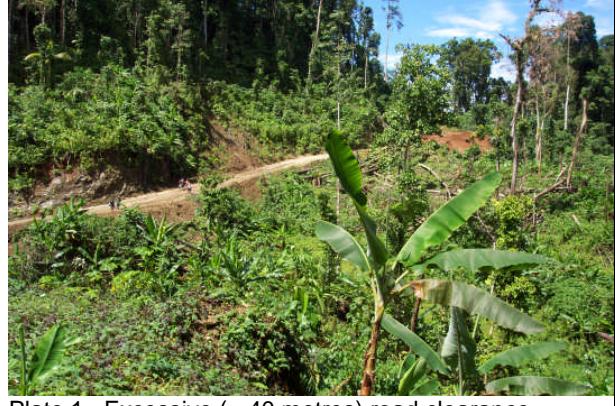
<p>Plate 1. Excessive (> 40 metres) road clearance.</p>	<p>Plate 2. Excessive road clearance due to bad planning.</p>

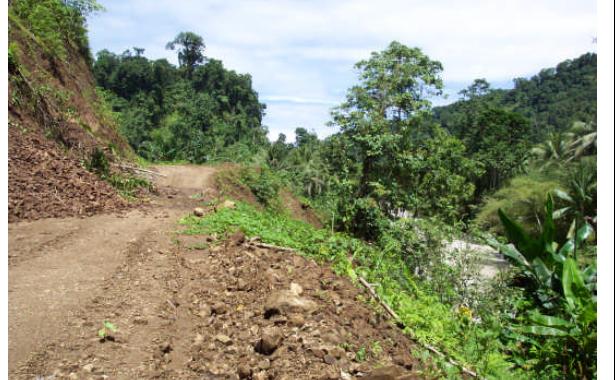
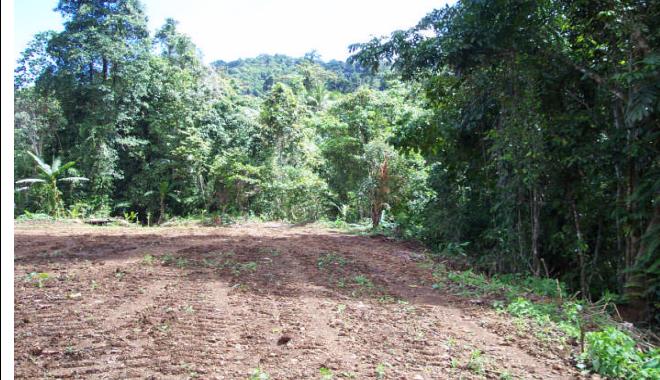
<p>Plate 3. Road alignment within buffer zone.</p> <p>Plate 4. Buffer zone cleared for transit camp.</p> <p>Plates 1-4 Show the road from Wangidu to Kiserawa. This road has been constructed along the side of a steep slope and often within the buffer zone of the Bonum River. Soil slipping into the river is excessive.</p> <p>The road should have been planned in consultation with the Morobe Provincial Works Department.</p> <p>Plate 5 Shows the River Buseng, which was in flood during the five days of the field trip.</p>

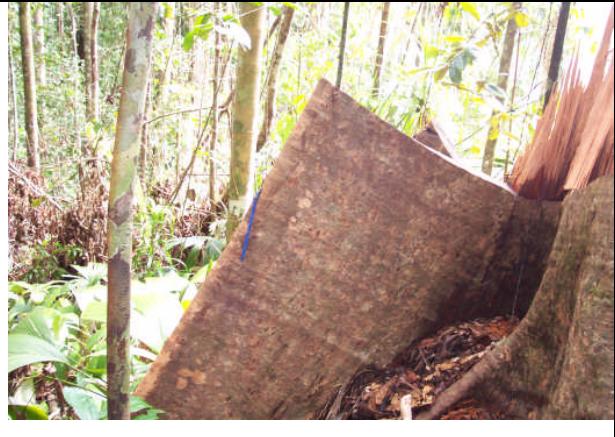
<p>Plate 6</p> <p>←←This flagging tape is meant to show direction of felling. The tree fell in the opposite direction.</p> <p>A painted arrow should be used for clearer instruction to chainsaw operator.</p>

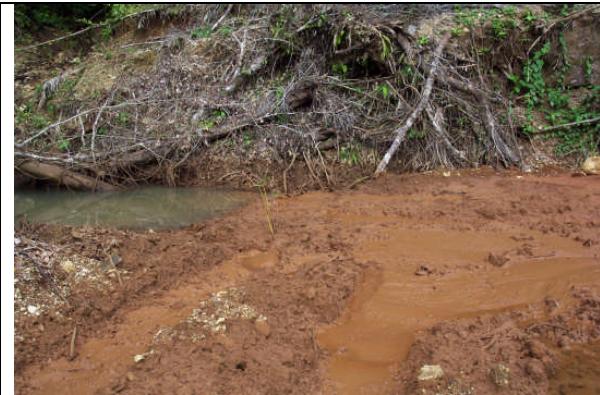
Plate 7. Excessive soil in a stream.

This blocked log culvert is typical of many along the road that links Wangidu to Kiserawa.

A landowner has opportunistically planted a ← sago palm in the swamp created by the blockage.

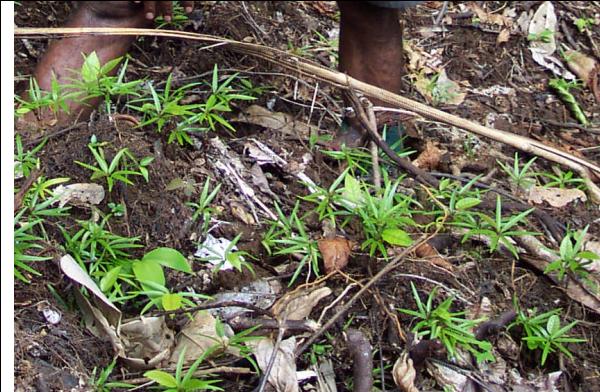
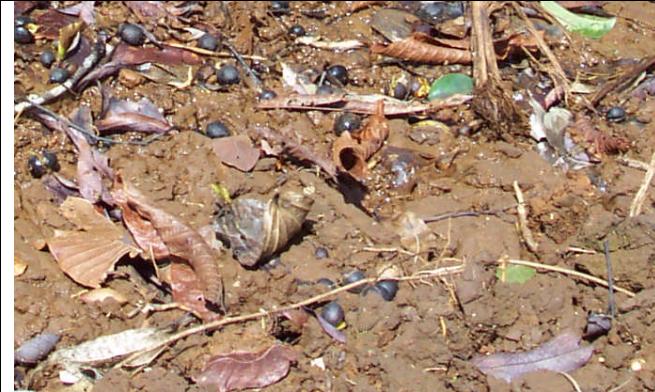
Plate 8. Seedlings of Grey Canarium.

Plate 9. Seedlings of Endiandra spp.

Plates 8 and 9 show seedlings growing along a snig track in a set-up that was left partly logged and will be destroyed once logging recommences, unless transplanted.

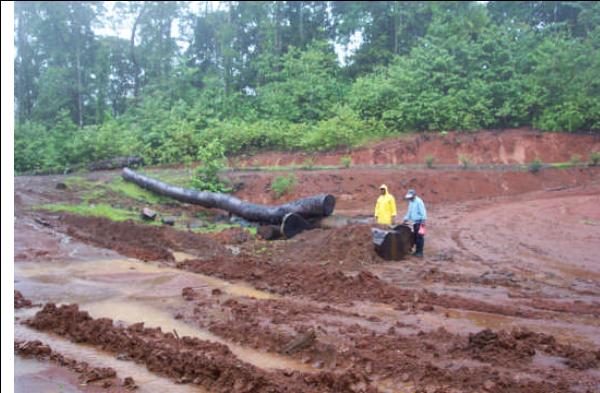
Plate 10. A reject log, should not have been felled.

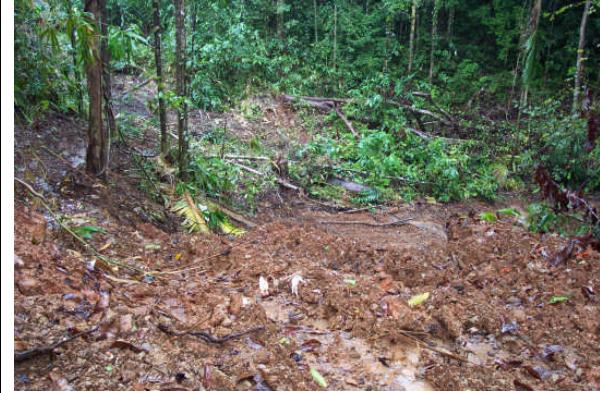
Plate 11. Re-logging, in 2003.

This photo was taken in a set-up that was first logged in 1999 and is currently being logged again, though the area was abandoned temporarily in June.

Advanced regeneration has been destroyed.

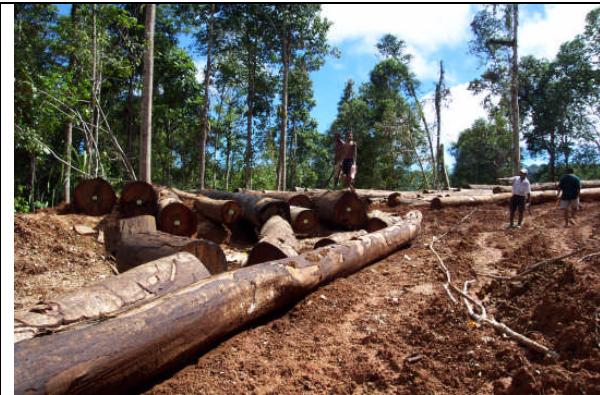
Plate 12. Logs from second cut.

This photo shows a large number of logs that have been extracted from the area illustrated in Plate 11, which was first logged in 1999.

Logging in this set-up was disrupted in 1999 due to landowner disputes, which are common in this project area, even within a set-up that has been cleared for logging by the “papa graun”.

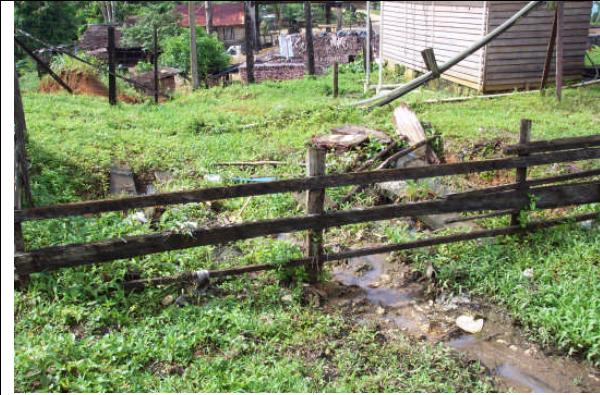
Plate 13. Sewage system at Mangec Base Camp.

The sewage system at the Mangec base camp is inadequate and unhygienic.

The water shown flowing during a shower of rain flows into a stream.

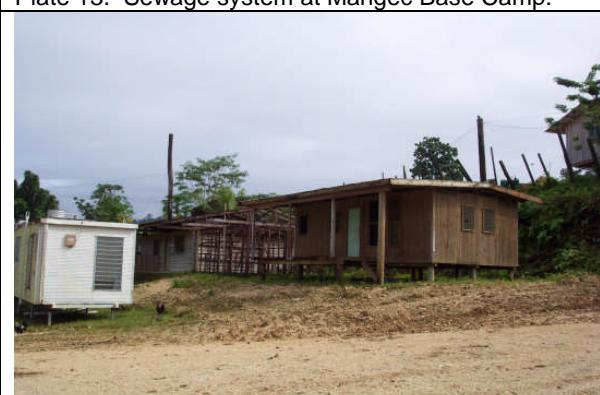
Plate 14. PNGFA House and Office, Mangec Log Pond.

The transit office/camp and incomplete house at the Mangec base camp is the PNGFA Project Supervisor's accommodation and office.

The house is due for completion shortly; the project is in its sixth year of operation.

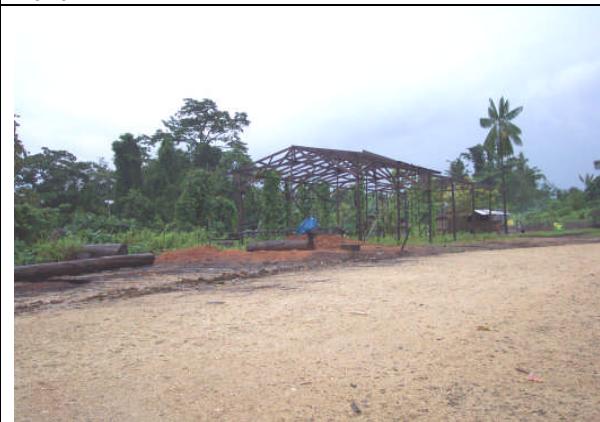
Plate 15. Abandoned Attempt at Sawmilling.

Plate 15 Shows the frame of initial attempt to establish downstream processing at the main Camp site and log pond (Mangec).
