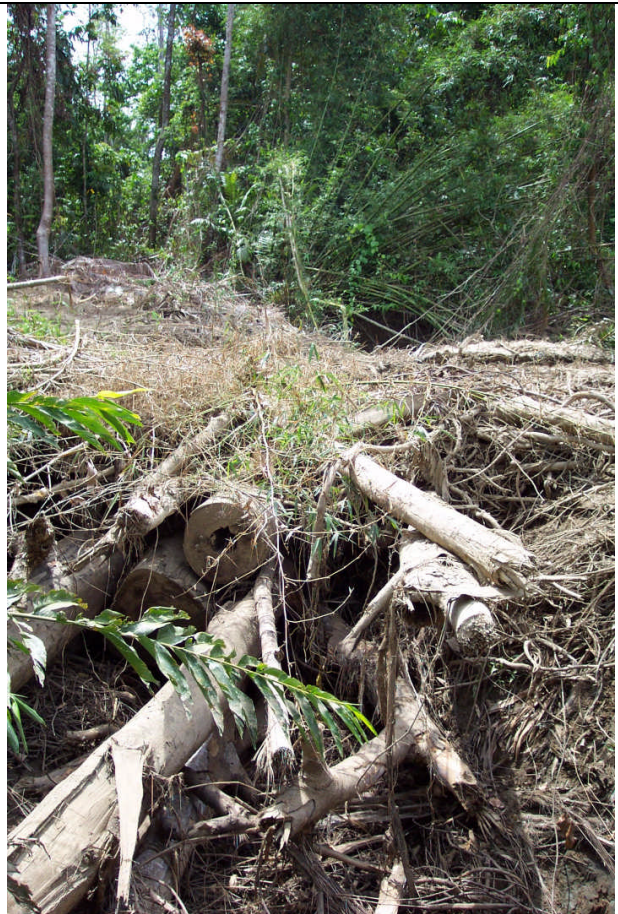
Plate 2 Log Clusters. Breach of Key Standard No. 13.

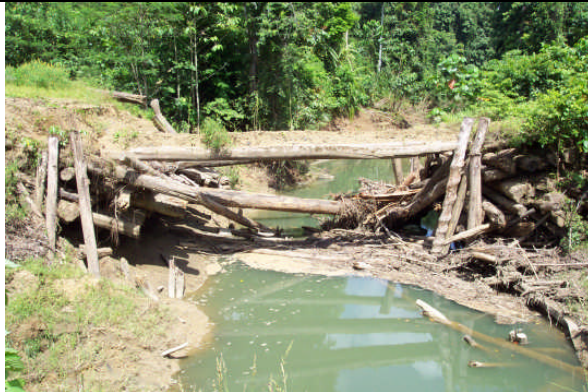
Plate 3 Old river crossing not decommissioned.

← This is an old disused bridge that should be decommissioned and debris removed from the stream to allow the water to flow freely ((Hihio River).

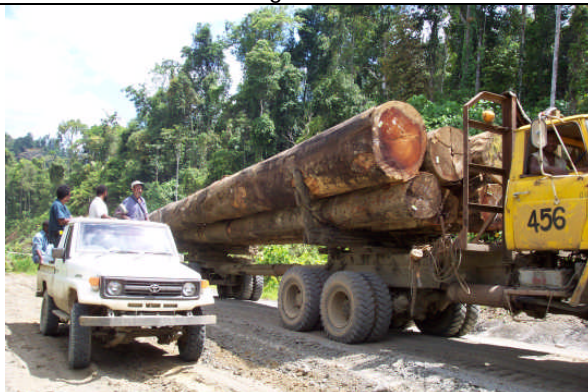
Plate 4 A fully loaded Jinker without chains.

During the field inspection on 23 rd October 2003, four logging trucks were observed to be driven without chains to secure the logs.

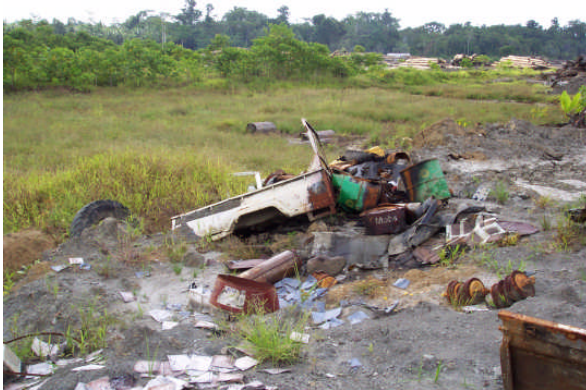
Plate 5 Exposed workshop waste.

This photo illustrates inappropriate disposal of waste at the Base Camp.

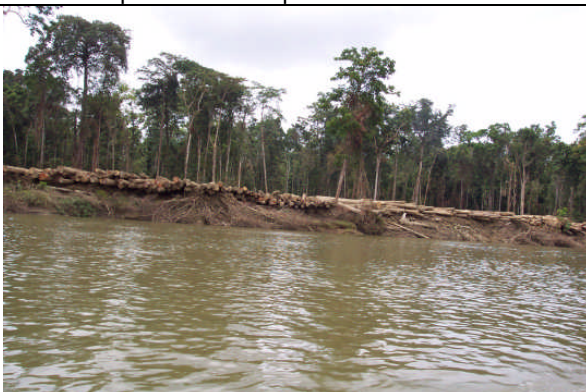
Plate 6 One of eight "River Dumps" along the Vailala River, between the Ihu station and the Hepea Base Camp (set-up SO3-04/C21).

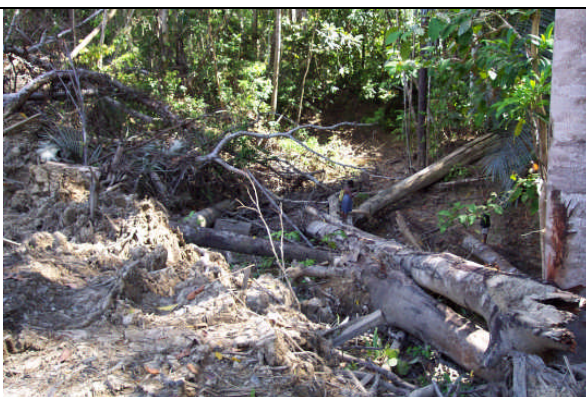
Plate 8 Excess soil and log debris in stream.

This photos shows how a bulldozer has pushed soil and log debris into a stream causing ponding in set-up 02 (contingency 02). This is in breach of Key Standard 6.

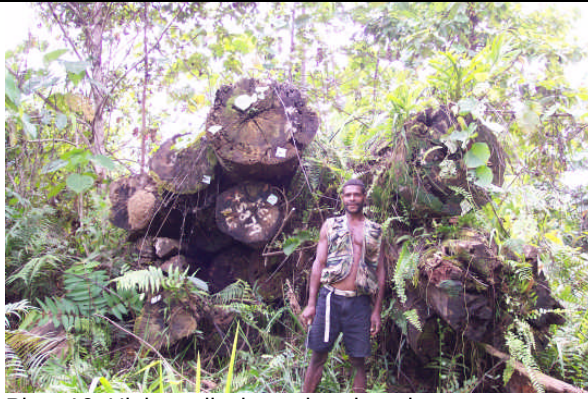
Plate 10 High quality logs abandoned to rot.

This pile of logs was abandoned after the operations in the Opoa area were disrupted. The logs have been prepared for export, tagged and left to rot (located at GPS 07°51'32" S, and 145°42'44"E).

Many more such logs were seen by the Review Team in the area either at abandoned log landings or along the roadside.

This is a considerable waste of a valuable resource and a loss of tax revenue for the national government, even if royalty has been paid to the landowners.

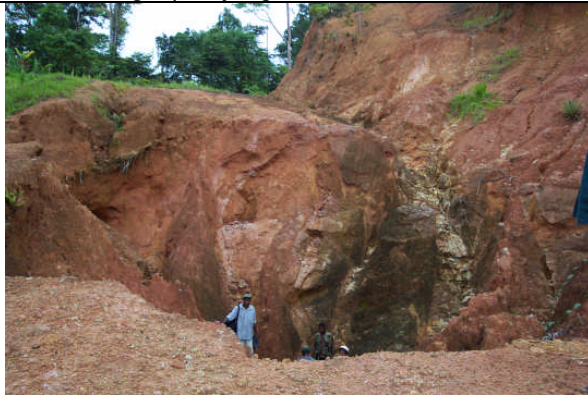
Plate 11 The Bluff-Mamuro road, a provincial highway.

This part of the Bluff to Mamuro road has collapsed due to inadequate construction standards and maintenance even though this road is noted in the Project Agreement (4.1, (b) (i), to be constructed ...to a standard which;

- (i) is equal or greater than that determined in accordance with the Department of Works Design Manual Part 2, Rural Roads for Medium Traffic Category.
- (ii) incorporates permanent materials for all drainage structure; and
- (iii) is trafficable in all weather conditions by conventional two-wheel drive vehicles.

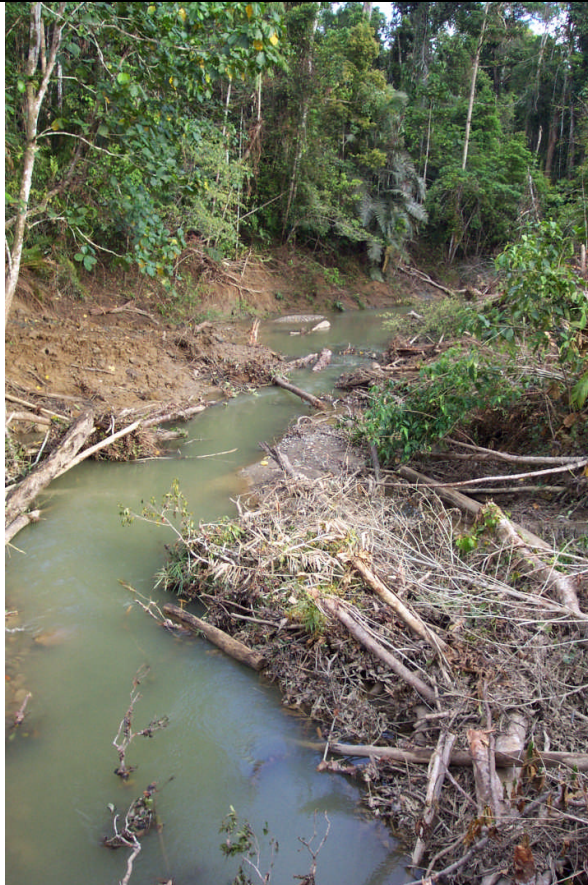
Plate 12 Breaches of Key Standards 1 and 10.

Another example of excessive disturbance to, and debris in, a Class 2 stream.
