Plate 1 Unsafe work practices, Serebi Base Camp.

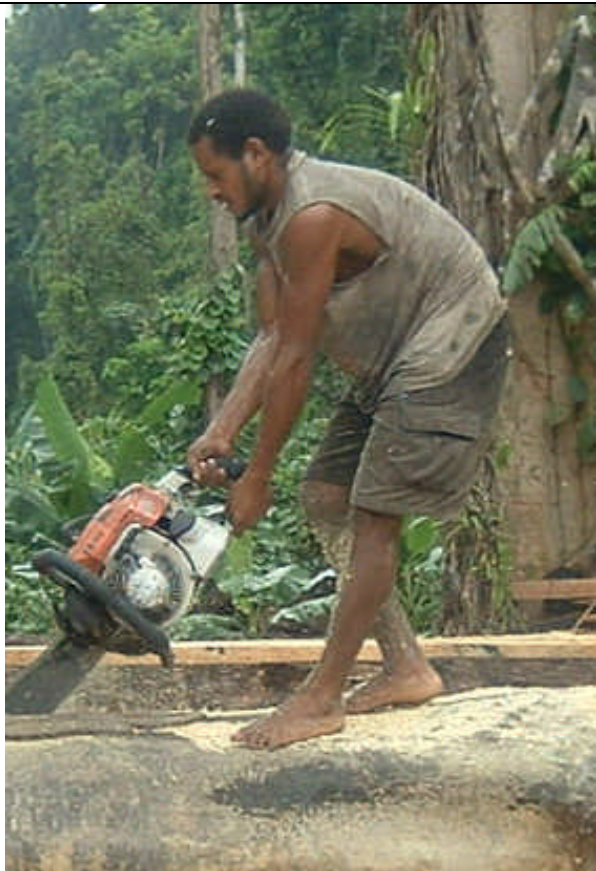
A chainsaw operator at the Serebi Base Camp. The photo illustrates a common feature of all logging operations visited by the Review Team to date, the absence of safety gear and inadequate Operational Health and Safety considerations.

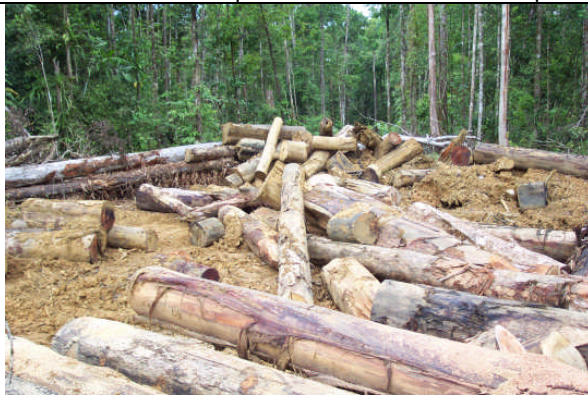
Plate 2 Excessive waste trimming at log landings.

Plates 2 and 3 Below illustrate the excessive trimming of logs during scaling before the logs are measured and tagged for royalty purposes. The log next to the Project Supervisor is actually marked S/M meaning suitable for sawmill and has been measured and tagged for royalty purposes. However, as there is no sawmill it is likely that this log will also be wasted. Plate 3 ↓

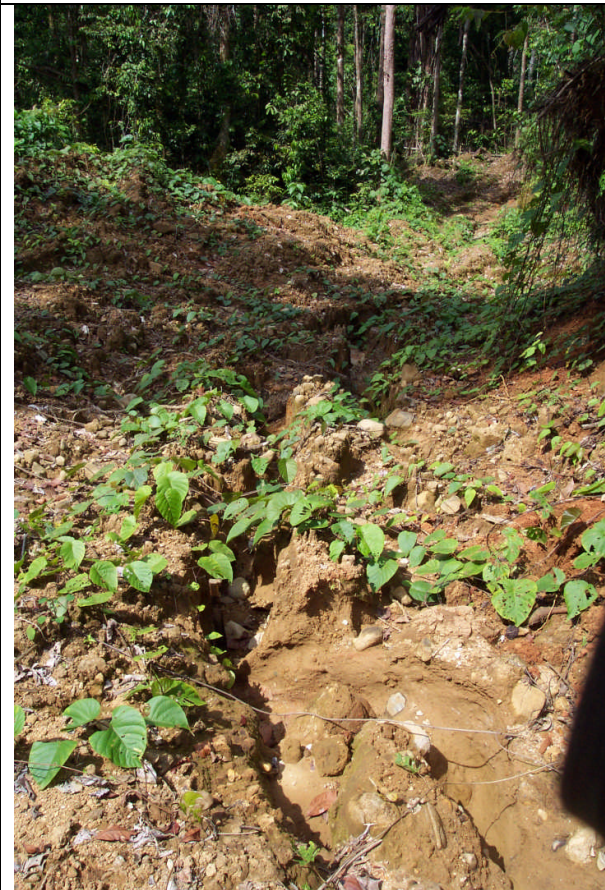
Plate 7 Erosion caused by lack of water bars.

←This photo was taken in a set-up cleared in June 2003 and shows that lack of proper water bars has caused serious erosion channels.

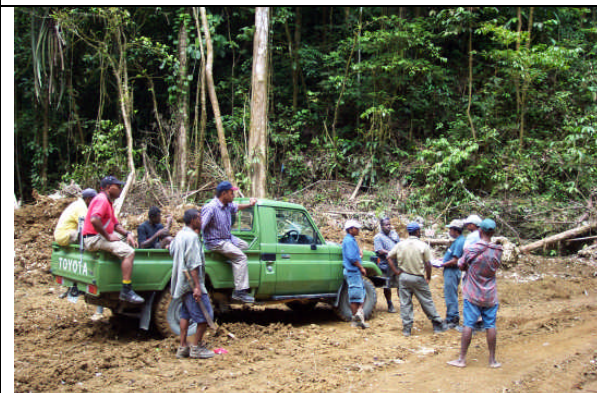
Plate 8 Trying to locate the snig track.

The photo below (Plate 9) shows a snig track within a karst landscape. In such landscapes location options for skid tracks is limited because of the terrain.

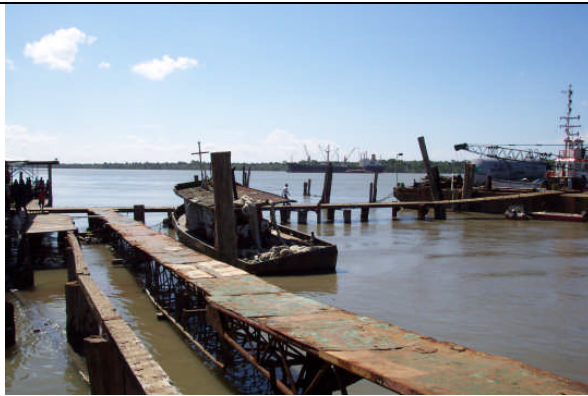
Plate 10 An old tug boat at Paia Inlet destined to sink and cause pollution to marine life.

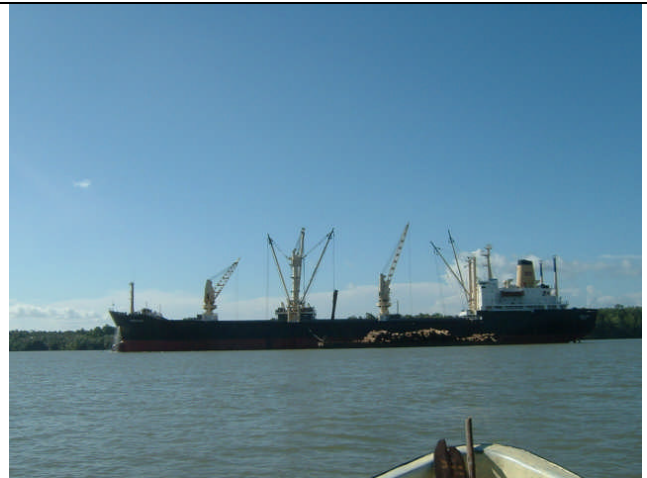
Plate 11. Loading logs at Paiai Inlet.

These photos show the generally unsatisfactory situation at Paia Inlet where water ways landowners have long complained about the deterioration to their marine resources by logging operations from which they receive little benefit.

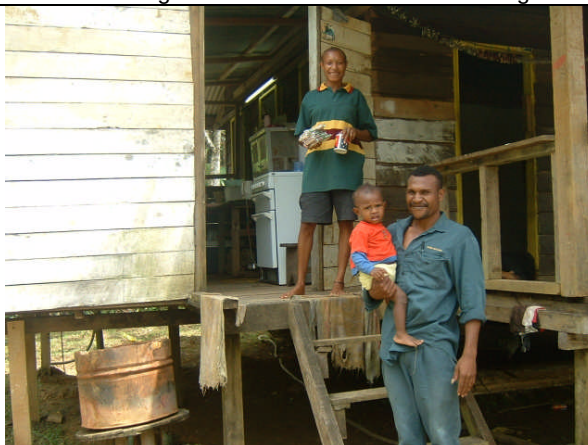
Plate 14 PNGFA Monitoring Officer and Family.

This photo show the Monitoring officer and his families living quarters provided by Turama Forest Industries Ltd at Victory Junction. The family occupies half of the house with single employees occupying the other half.

The photo illustrates the need for PNGFA staff to be housed properly by their own organization to ensure independence.
