These three photos were taken in a set-up in the Molkolkol TRP that was logged in 1982.

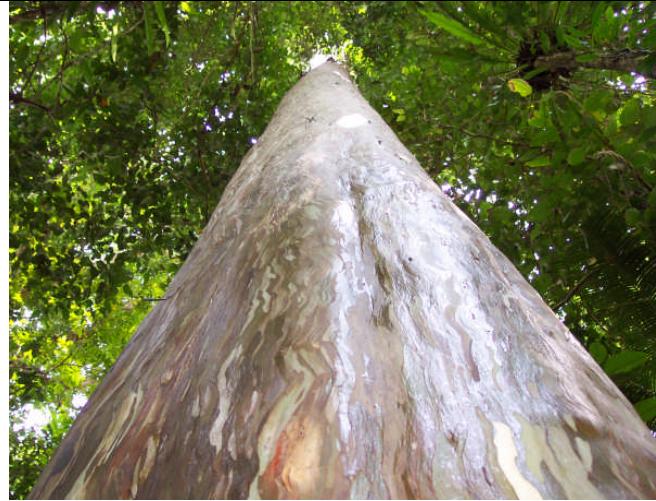
Plate 5 This is the same tree as Plate 4, *Eucalyptus deglupta*, showing the excellent form and log length.

The photo shows that this tree is a residual left after the 1982 logging operation when presumably it was considered too small for commercial purposes. The question remains now is it sound? A simple drill attachment to a chainsaw is apparently available to test such trees. If found unsound, the tree should be left as a seed source.

←← The old stump of a tree felled in 1982.

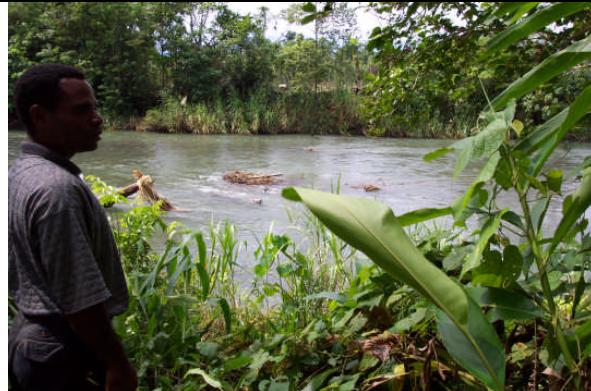
Plate 9 The site of the bridge over the Nesai River

A temporary log bridge was washed away and the permanent bridge construction is awaiting Department of Works approval.

In the meantime all vehicles, including jinkers, ford the river upstream from the bridge site where the river breaks into several smaller channels.

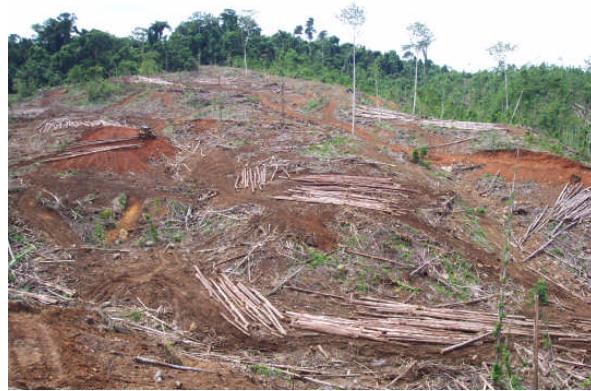
Plate 10 A clearfelled *E. deglupta* (kamarere) plantation.

This photo illustrates the excessive disturbance to the topsoil caused during the extraction of the logs even though the company has purchased smaller dozers for this operation.

There are also an excessive number of log landings.

The PNGFA Project Supervisor has recently recommended that a Code of Logging Practice be introduced for plantation logging.

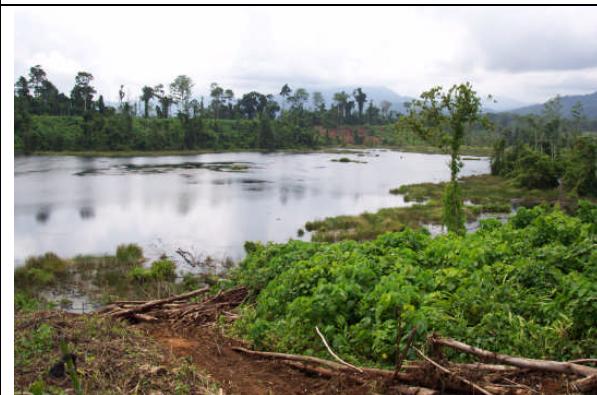
Plate 12 A lake in a forest plantation

This lake is in a recently felled forest plantation. The photo shows there was no consideration for an adequate buffer to protect the lake when the plantation was first established.

The recent fellings should have also left a buffer.

This is further indication of the need for a Code of Logging Practice for forest plantations.

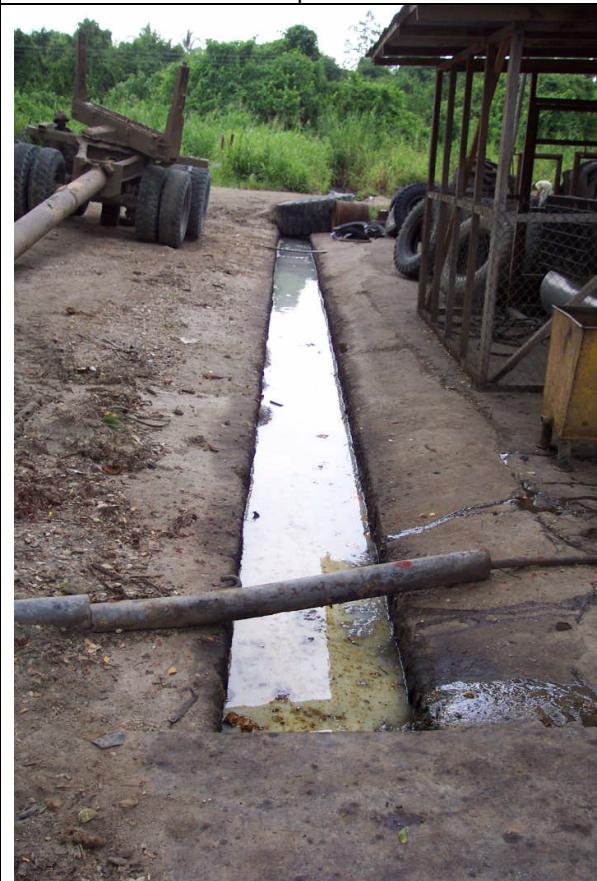
Plate 13 Drainage for the workshop.

These photos show the need for considerable improvement in waste oil and fuel/spill management. The absence of a bund around the generator shed (photo not shown) adds to this contamination of ground water.

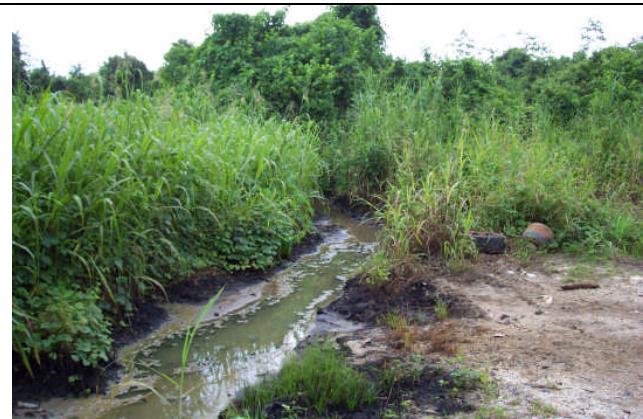
Plate 14 A small drainage channel leading through the swamp towards the beach.
