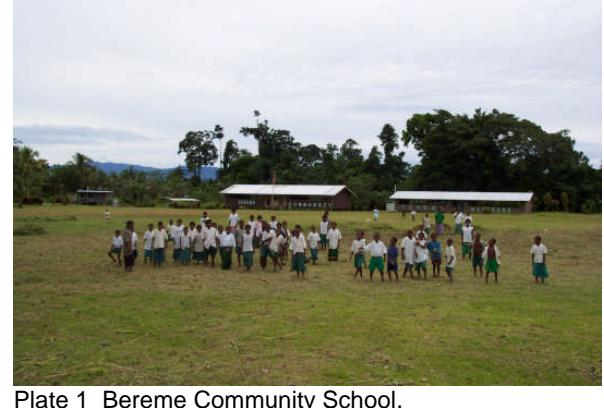
<p>This school was supposed to be constructed at Umoa Village, but the communities agreed to have it constructed at Bereme Village, as the population at Umoa has declined.</p>
