These three photos were taken in a set-up in the Molkolkol TRP that was logged in 1982.

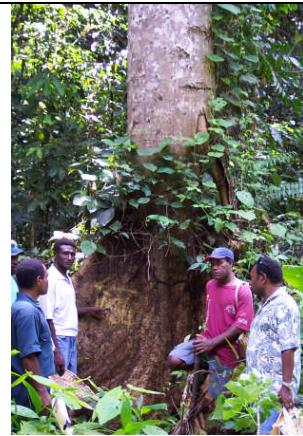
Plate 1
Octomeles sumatrana
regeneration 22 years
after logging

These trees have reached commercial size and are marked for felling at age 22 years.

The rapid growth is partly due to the trees location at the edge of the old logging road.

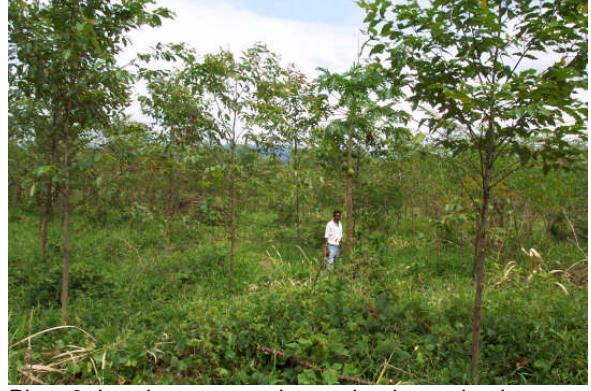
Plate 8 Landowners garden under the replantings.

The practice of allowing landowners to garden under the replanted trees is welcomed by the people from Open Bay and contributes to the good working relationship between the people and Open Bay Timbers Ltd.

When used properly this is also a good silvicultural technique.
