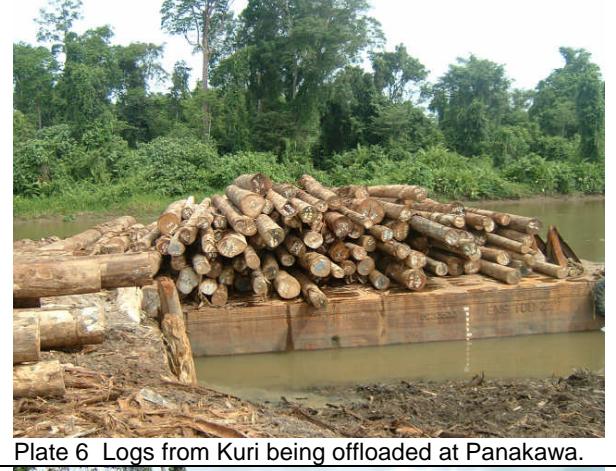
<p>A barge of logs from Kuri (Turama Forest Industries Ltd Timber Permit), being offloaded at Panakawa. SGS (PNG) Ltd officers noted that barges were also arriving from the Vailala (RH subsidiary) operations.</p>
