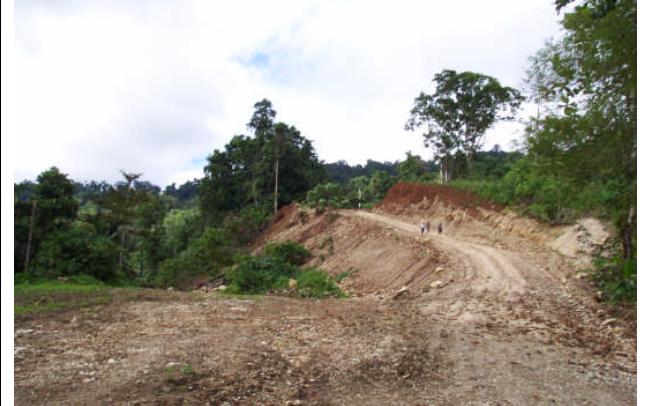
<p>Plate 1. Excessive (> 40 metres) road clearance.</p>	<p>Plate 2. Excessive road clearance due to bad planning.</p>

<p>Plate 3. Road alignment within buffer zone.</p> <p>Plate 4. Buffer zone cleared for transit camp.</p> <p>Plates 1-4 Show the road from Wangidu to Kiserawa. This road has been constructed along the side of a steep slope and often within the buffer zone of the Bonum River. Soil slipping into the river is excessive.</p> <p>The road should have been planned in consultation with the Morobe Provincial Works Department.</p> <p>Plate 5 Shows the River Buseng, which was in flood during the five days of the field trip.</p>
