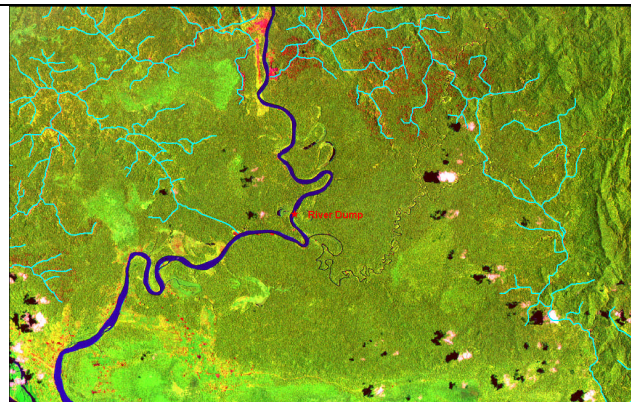
Plate 7 The location of this "dump" on a satellite photo taken in 2002. Blue lines indicate logging roads constructed up to December 2002.

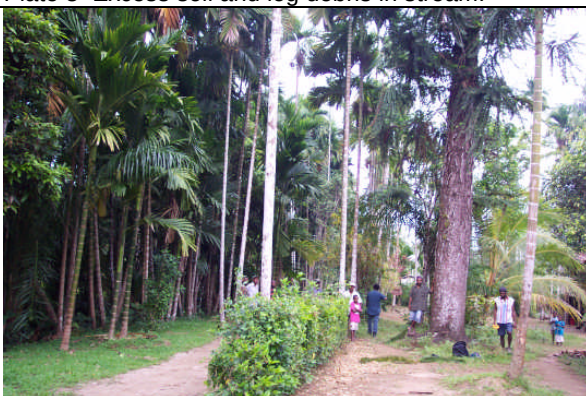
Plate 9 This Klinkii pine is over 90 cm dbh age 40 years.

This Klinkii pine (*Araucaria* spp), is estimated to be approximately 40 years old, by the son of the person who planted a few of these trees in the village of Merikera. One of the trees has been converted into sawn timber and used for construction of a house.
