Plate 1 Unsafe work practices, Serebi Base Camp.

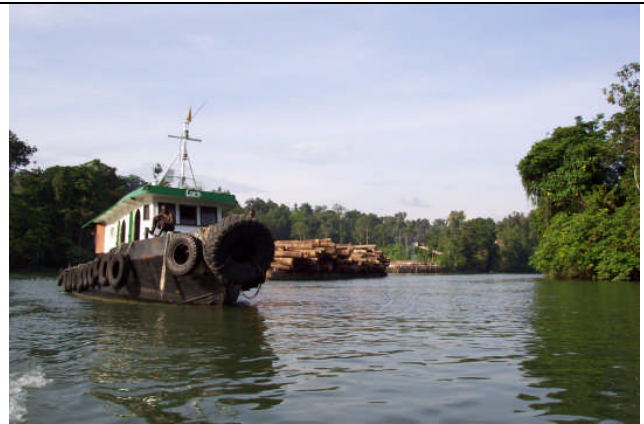
Plate 6 A "dumb" barge loaded with logs .

Plates 5 and 6 show the operations of the Serebi Base Camp.

The Base Camp is well set-up and has minimum clearance of the river buffer zone (ie within the 100 metres permitted under the Key Standards). This Log Pond along with the Log Pond at Victory Junction were the only examples of compliance with the Key Standards for "River Dump" Log Ponds seen to date by the Review Team. The "dumb barge" is destined for Paia Inlet.

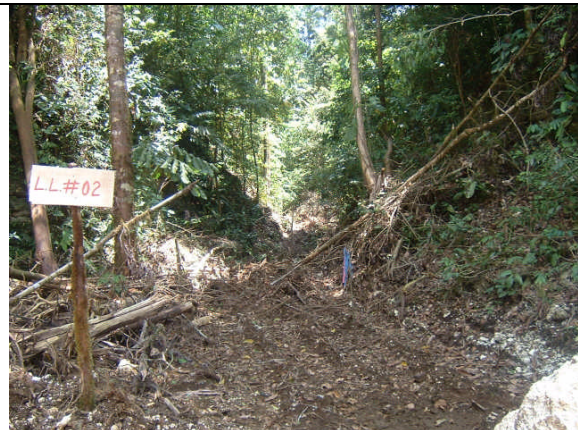
The photo below (Plate 9) shows a snig track within a karst landscape. In such landscapes location options for skid tracks is limited because of the terrain.
